Manhole Inspection Summary

Manhole # S37U__035MH

Location Address: **unknown alley, behind 1446 William Street**

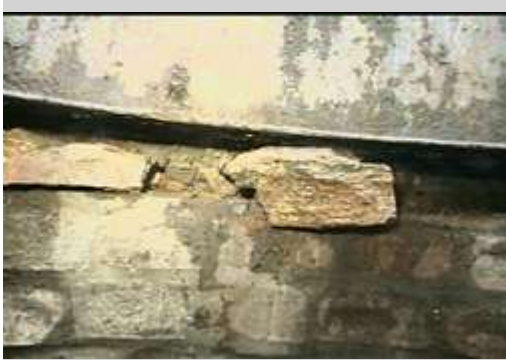
Defect 2

Condition: ☐ Sound ☐ Cracked ☐ Root Intrusion ☒ **Loose Brick** ☐ Deteriorated

loose bricks in Chimney

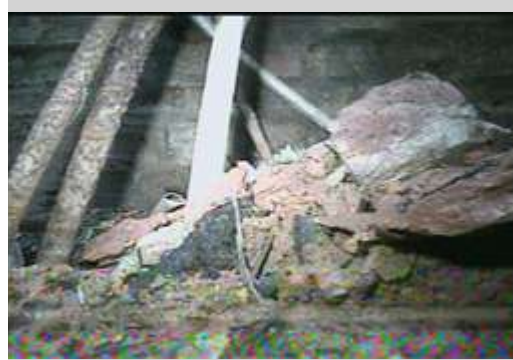
Defect 1

Condition: ☐ Sound ☐ Cracked ☐ Root Intrusion ☐ Deteriorated ☐ Leaks ☒ **Debris**

debris in channel

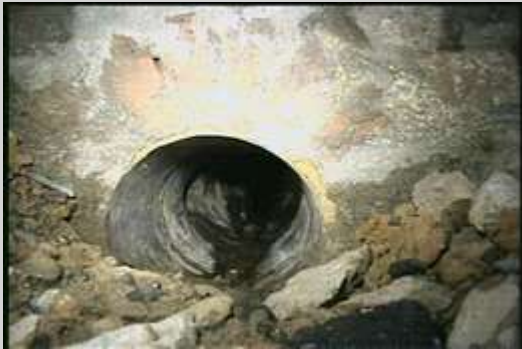
12 O'Clock Outflow

8 in. Circular Gravity Sewer
Pipe Out @ 12 O'Clock

Deposits: ☒ None ☐ Mud ☐ Sludge ☐ Debris ☐ Grease

Infiltration: **None** Pipe Seal Cond: **Unknown**
